# Kembangan Dam Safety Risk Index Sragen Regency

<sup>1,2,3</sup>Universitas Diponegoro, Semarang, Indonesia

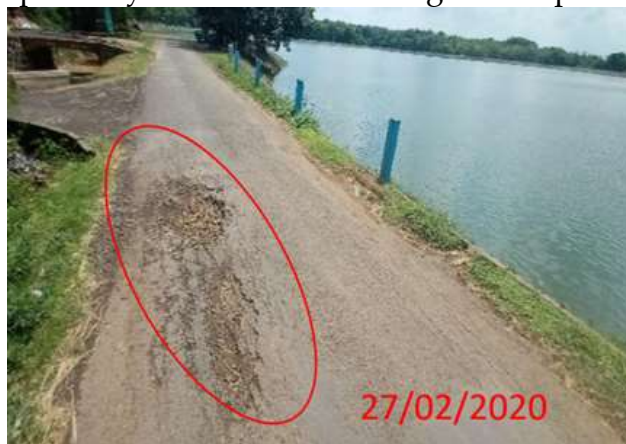
**Figure 1. Condition of the Dam Top**

Based on the results of the inspection, it was found that the top of the dam uses an asphalt layer which is in a damaged condition. This damage is caused by the old asphalt reinforcement layer. Recommendations for this damage are immediately made to repair the asphalt layer and create drainage at the peak.

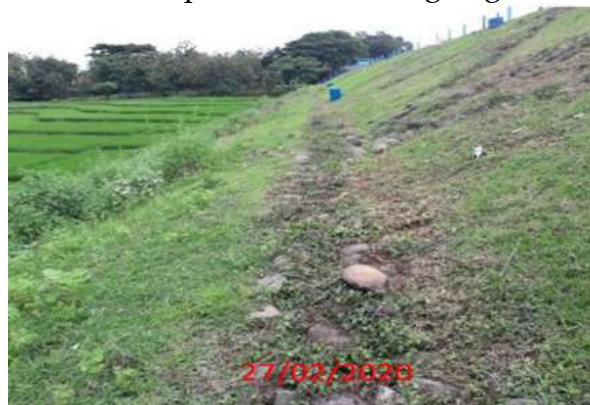
**Figure 2. Condition of Dam Slopes**

On the slopes of the dam, there are *fishbones* that are in poor condition and many of them are no longer there, which results in uncontrolled rainwater flow and disrupts the safety of the dam. On the slopes, the rip-rap is scattered and much of it is missing. The recommendation for this damage is to immediately tidy up *the fishbone* and rip-rap structures and clean up the surrounding vegetation.

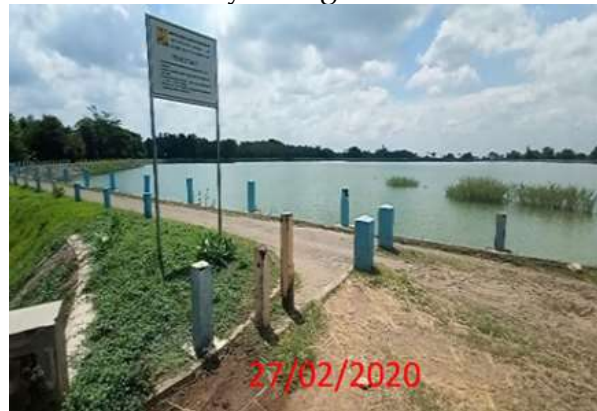
**Figure 3. Condition of Inundation Area**

In the dam inundation area, sedimentation and wild plants were found because the inlet channel carried a lot of sediment and the useful life of the reservoir was quite long. This results in the effective reservoir capacity being reduced. The recommendation for this damage is to immediately dredge the reservoir sediment.

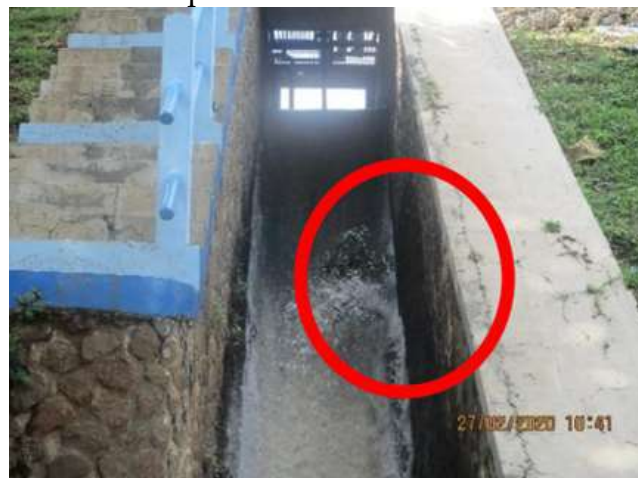
**Figure 5. Condition of the Spillway Building**

From the results of the inspection, it was found that the inspection ladder on the launch wall was cracked and peeling and wild plants such as grass and moss were growing on the spillway building. Recommendations for this damage are immediate repairs and maintenance so as not to disrupt the stability of the dam. In the stilling pool, there doesn't seem to be a problem.

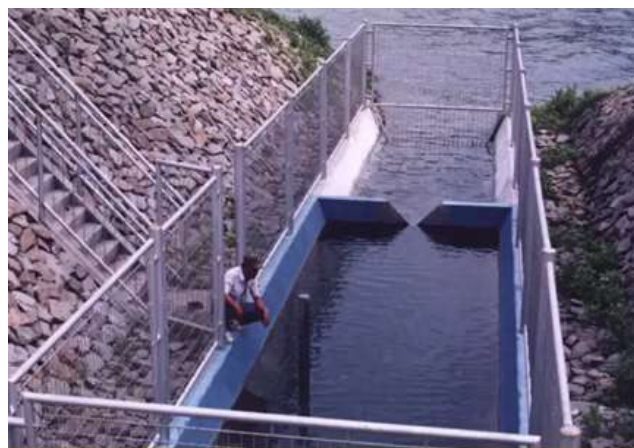
**Figure 7. V-notch Shape of the Dam**

At the Kembangan Dam, to measure seepage that occurs in the dam body, one uses a *toe drain channel* that ends at the V-Notch. Based on the results of the inspection, the condition of the V-notch is full of sediment and weeds or wild plants and is disturbed by the flow of water from residents' drainage which enters the V-Notch channel. This means that the flow through the v-notch cannot be used as a guide to the quantity of seepage that occurs in the Kembangan dam body. Therefore, improvements are needed to the Toe Drain channel so that the V-Notch function can be utilized properly.

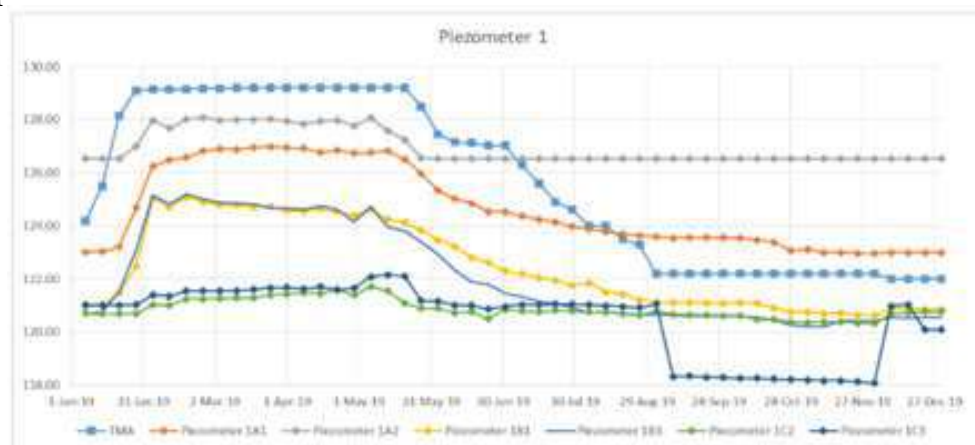
Figure 8. Piezometer Reading Graph 1

- 1). The condition of the graph line being flat indicates that it has reached the tip elevation or lower end of the piezometer.
- 2). The condition of the graph line that is above the Water Level line indicates that there is a problem with the piezometer. Therefore, it is necessary to maintain piezometers, including by flushing piezometers that are indicated to have problems.
