# Kembangan Dam Safety Risk Index Sragen Regency

<sup>1,2,3</sup>Universitas Diponegoro, Semarang, Indonesia

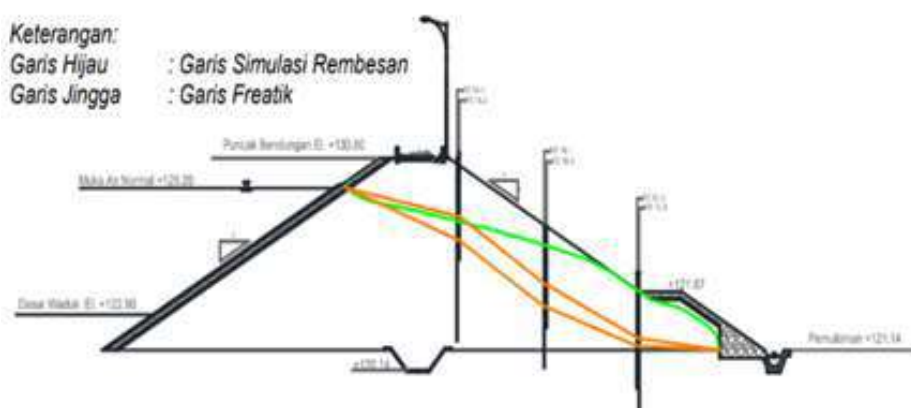
Based on the results of inspections in the field, it can be concluded that the Kembangan Dam has 35 piezometers with the location and condition of each piezometer, from which several conclusions can be drawn regarding the existing condition of the piezometers that have been installed in the field:

- 1). The condition of the graph line being flat indicates that it has reached the tip elevation or lower end of the piezometer.
- 2). The condition of the graph line that is above the Water Level line indicates that there is a problem with the piezometer. Therefore, it is necessary to maintain piezometers, including by flushing piezometers that are indicated to have problems.

Figure 9. Freatic Piezometer Line for Normal Water Level Conditions
